**East Demerara and
Boereserie Conservancy
Dams**

**Condition Assessment
by Dams Specialist**

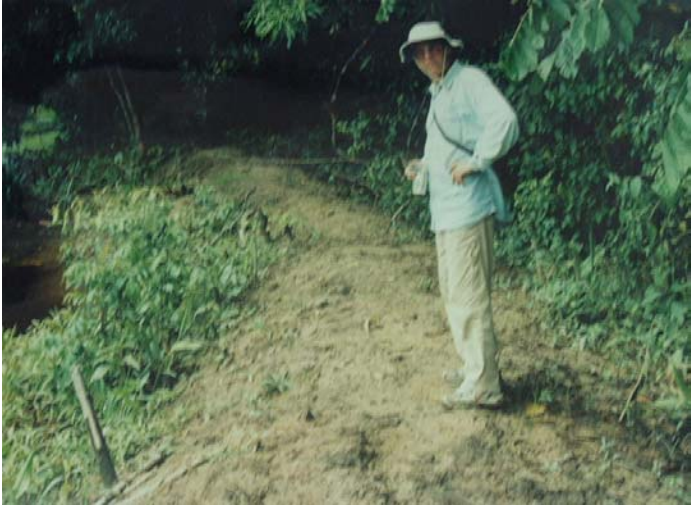
Photo 1: Vegetation on Eastern dam of EDWC

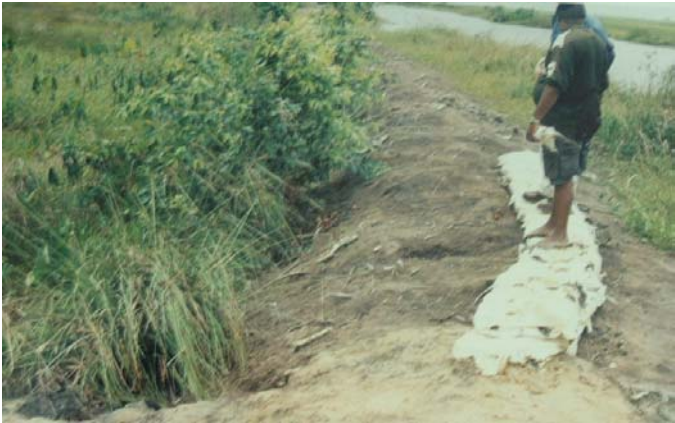
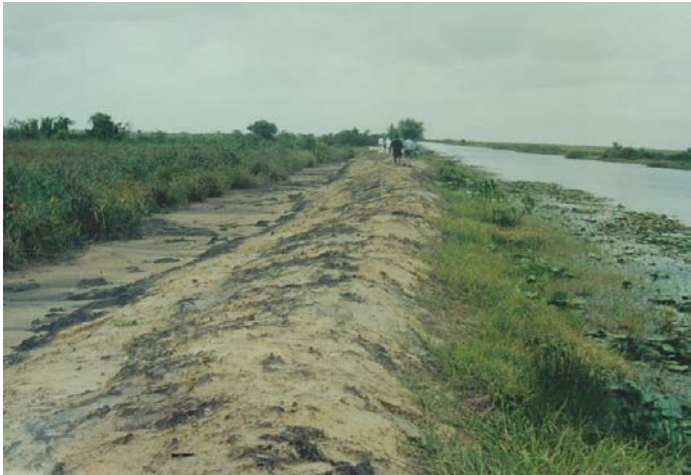
This embankment is founded on and constructed on weaker clays than the West Dam. There are no trees or bamboo on the embankment, but a good heavy grass vegetation except where additional fill has had to be placed at the crest. The latter has been necessary due to settlement of the crest over time, generally by hand. There was no evidence of significant slips on the downstream slope. Similarly the slips on the upstream side were limited to a relatively shallow depth from the crest. A typical view of this embankment is shown in Photo Nos. 2 and 3.

Photo 2: EDWC North Dam

Photo 3: EDWC North Dam

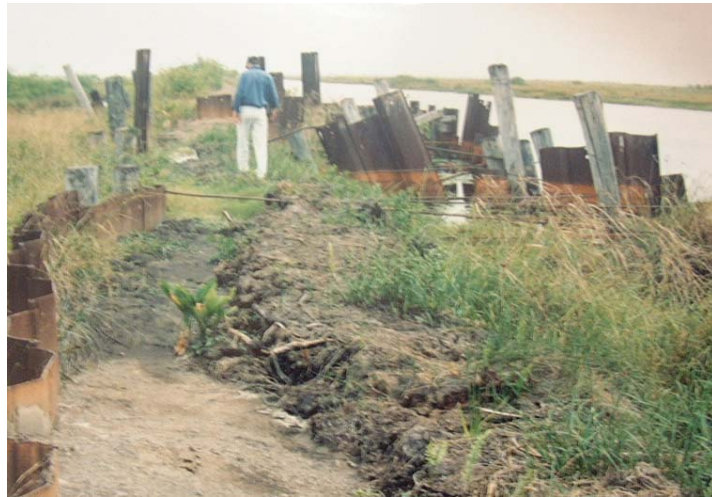
Photo 4: EDWC North East Dam location needing urgent repairs

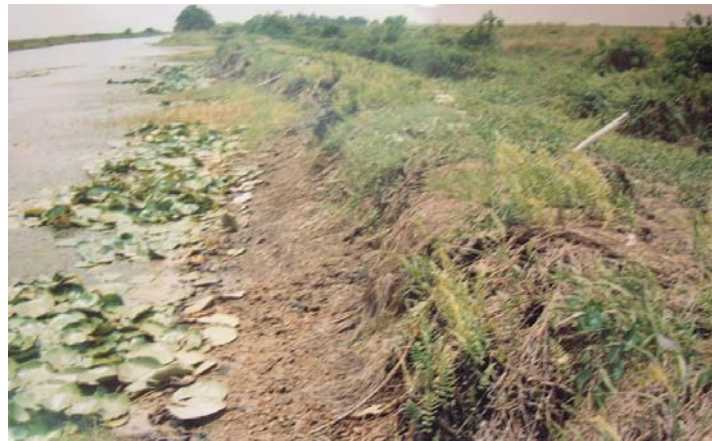
The weak construction has caused slips at the upstream slope along much of its length, and quite extensive in some places. The cause has been due to the normal drawdown of the reservoir from GD 57.5 ft to GD 54.0 during each dry season, but further aggravated by a deeper drawdown at times of drought. This was most critical in 1998, when the storage level was drawdown to approximately GD 51.0 ft and possibly lower.

Photo 5: EDWC poor condition of EDWC North East Dam: Upstream slips

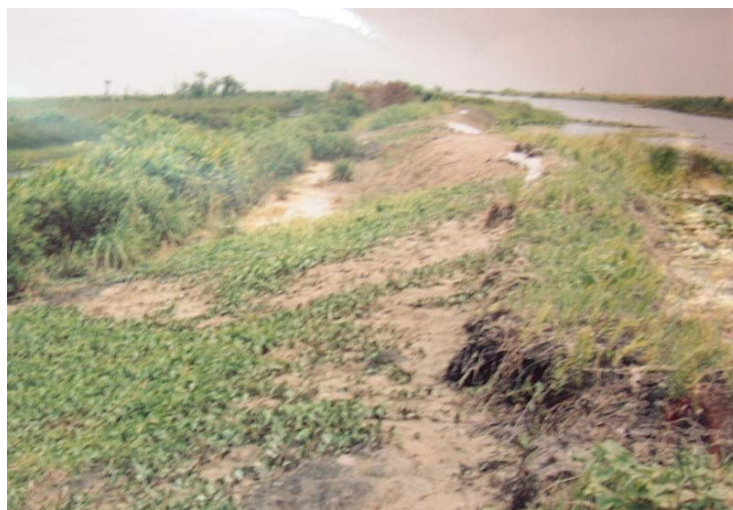
Photo 6: EDWC poor condition of EDWC North East Dam: Deteriorated Crest

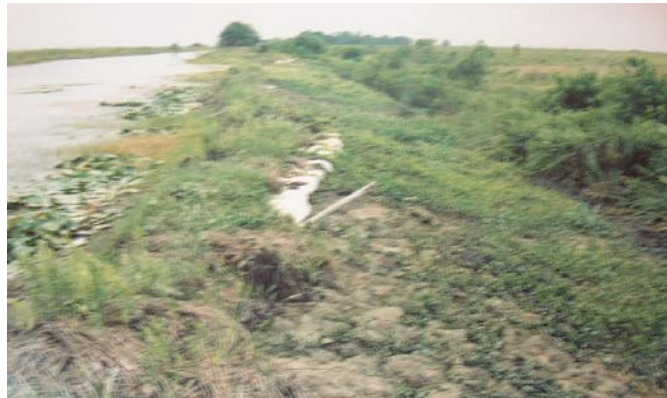
Photo 7: EDWC poor condition of EDWC North East Dam: Damaged Crest

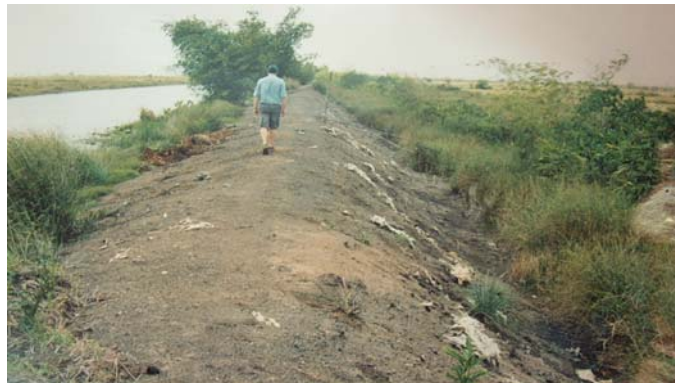
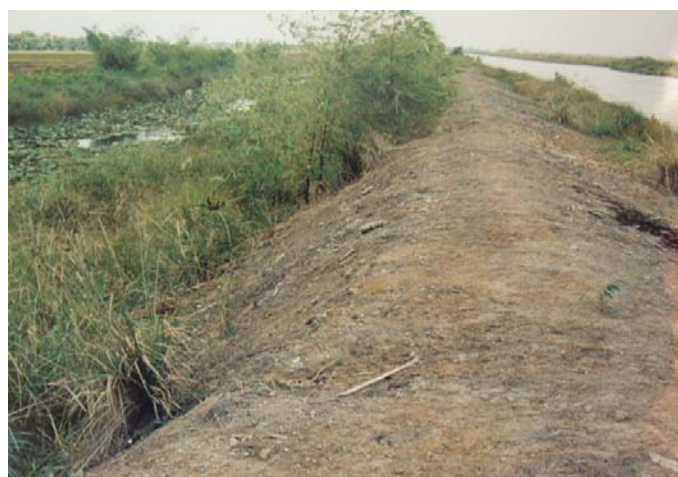
Due to significant settlement of the crest over time, once more reflecting the poorer construction, reconstruction works were carried out in 1995. Unfortunately the Contractor sourced much of his fill material directly downstream of the downstream toe of the dam, to depths of up to 10ft, and this caused breaches or major slips in several locations. At one location this necessitated urgent repair works using sheet piling. This location is shown in Photo No. 4. The poor condition of this embankment is also shown in Photo Nos. 5, 6 and 7. The crest re-instatement undertaken in January/February of this year and the proximity of the trench excavated for the borrow material, as referred to above, are shown in Photo Nos. 8 and 9.

Photo 8: EDWC North East Dam crest reinstatement: Repairs to crest

Photo 9: EDWC North East Dam proximity of borrow trench (flooded)

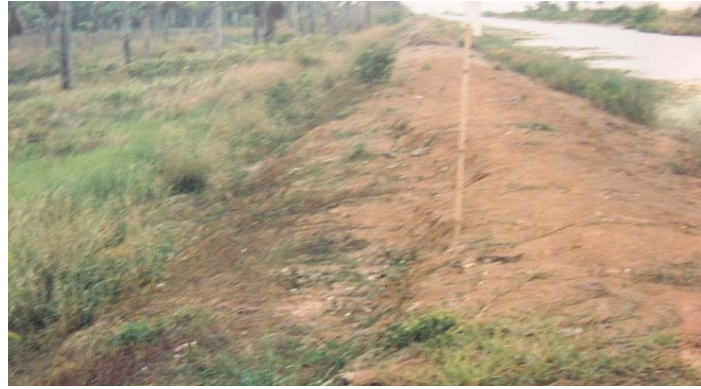
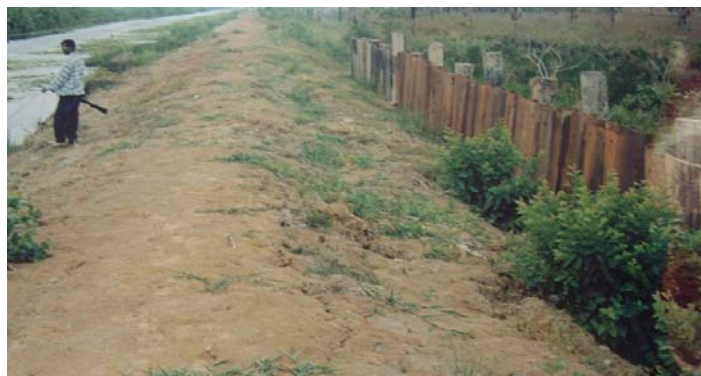
There are two locations along this dam where slope failures have occurred in the downstream slope. These are shown in Photo Nos. 10 and 11. The latter shows the emergency sheet piling which had to be placed. These two locations are in the northern part of this dam and, according to the Conservancy Maintenance and Security Officer, are at areas where there were originally stream courses. This cannot be confirmed. Elsewhere along much of this dam, there has been a need to raise the crest level due to settlement. This has been done by vegetation debris or occasionally sand bags, as shown in Photo Nos. 12 and 13. These can only be temporary measures.

Photo 10: EDWC East Dam downstream slope failure

Photo 11: EDWC East Dam downstream slope failure

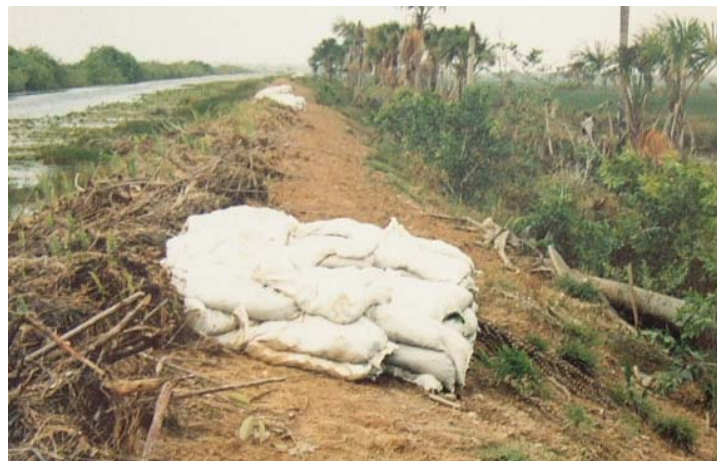
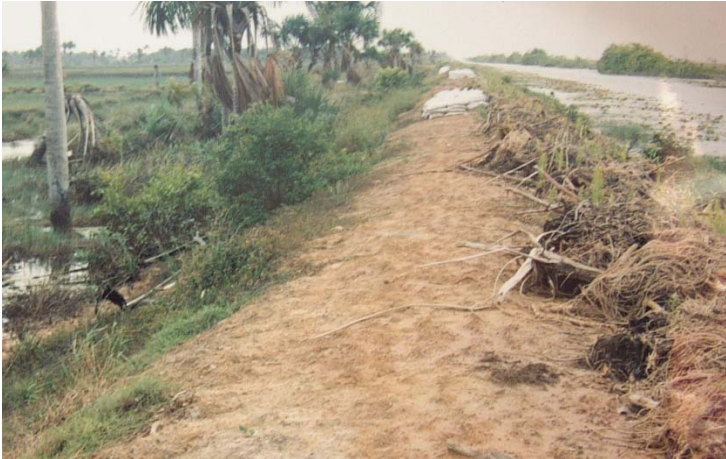
Photo 12: EDWC East Dam temporary crest repairs using vegetation

Photo 13: EDWC East Dam temporary crest repairs using vegetation

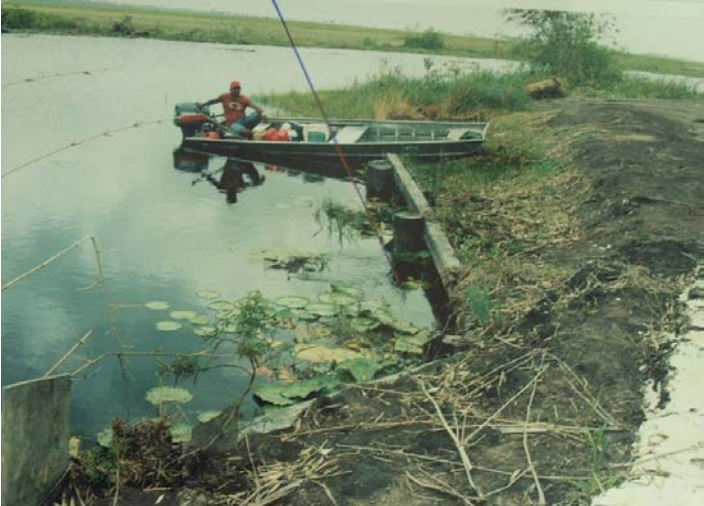
However there is a major seepage through the fill or structure at the offtake structure at Enmore in the North East Dam, which supplies the Guysuco sugar factory. This is an uncontrolled “koker”, which has a steel pipe in the foundation starting in the upstream canal. In addition there is clear evidence of a major leak from flow patterns visible directly upstream at the left hand side revetment. This is shown in Photo No 14. Unfortunately it is not possible to establish visually if the leak is through the fill or foundation or some original structure. At this stage the worst, i.e. through the fill, must be assumed.

The leakage occurring at the left revetment for this structure is of concern. Unless this can be rectified at the short term, which is unlikely, this leakage needs to be very closely monitored especially if the storage level increases during the coming few months.

Photo 14: EDWC North East Dam leak at Enmore Koker

Unfortunately it is not possible to see where the leakage is exiting on the downstream side, most probably directly into the downstream channel. It is recommended that a dye is used, introduced at the entry point, to try and establish where the leakage is exiting.

Irrespective of this, any deterioration will be evidenced by slumping of the crest or downstream slope at this location and/or by evidence of an increased discharge. If this does occur, there will be an immediate need to drive sheet piling at the centreline of the dam. However this will first require exposure of the tie rods supporting the existing sheet pile whalings, so as to avoid breaking these.

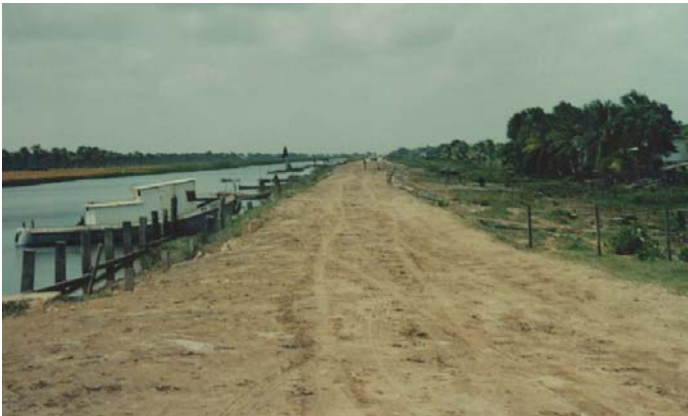
Photo 15: Boersarie East Dam typical view

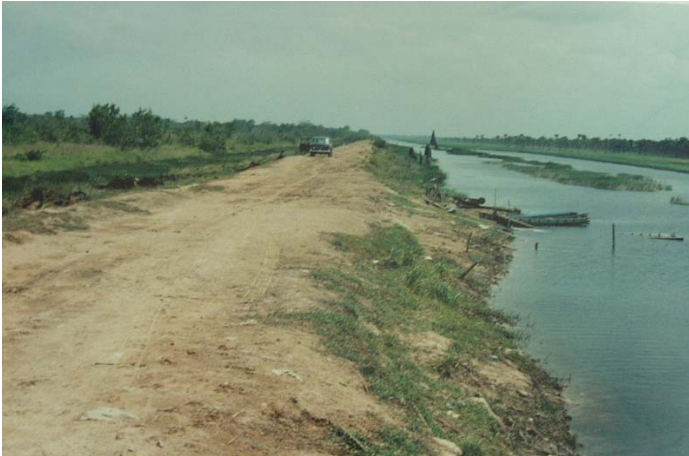
Photo 16: Boersarie East Dam typical view

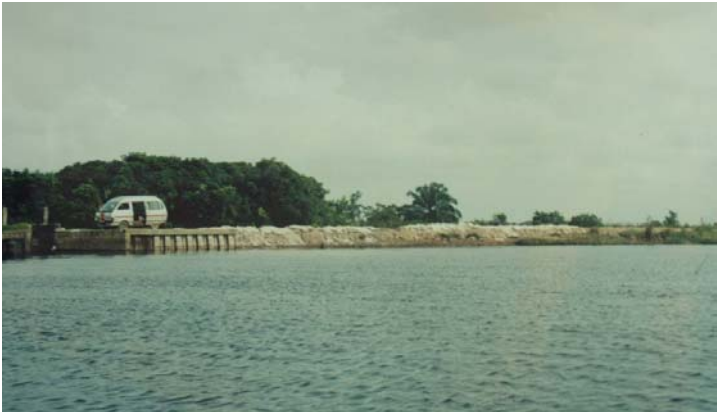
Photo 17: Boersarie East Dam broken sand bags

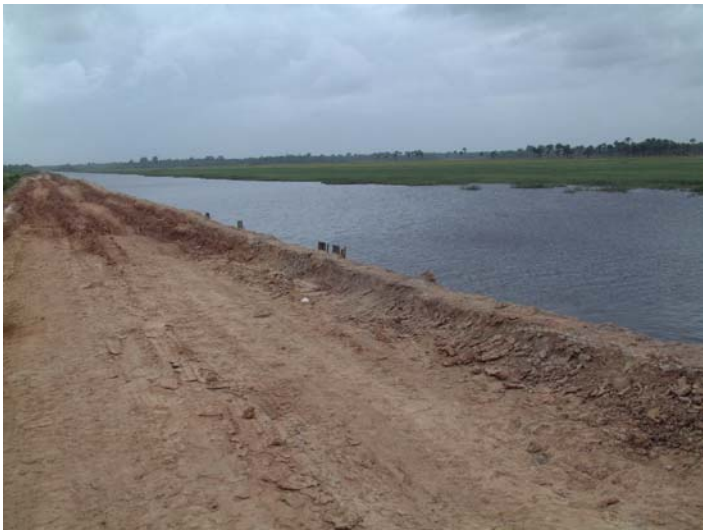
This is in a similar condition to the East Dam. A typical view is shown in Photo No 18.

Photo 18: Boersarie South East Dam typical section

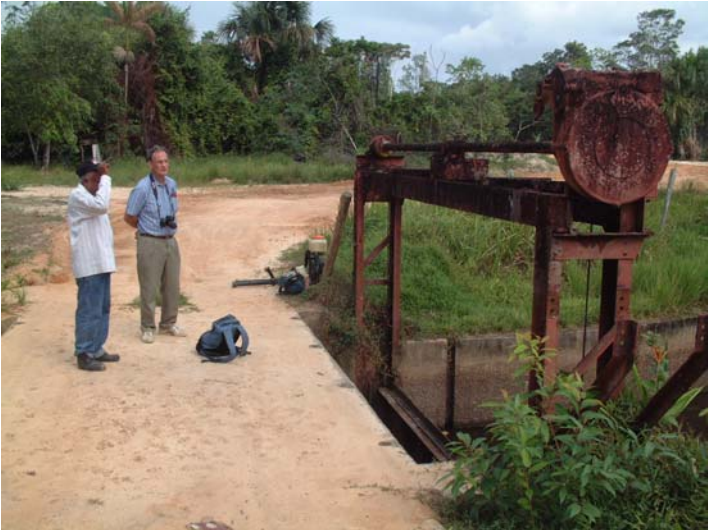
Photo 19: Boersarie Patosi Relief Sluice

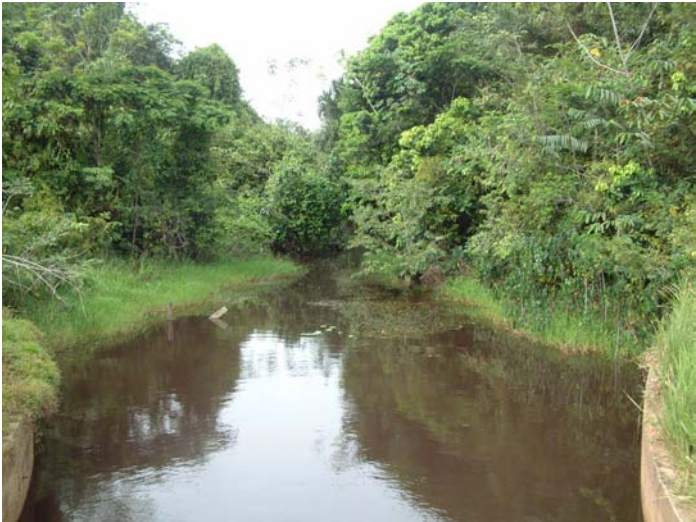
Photo 20: Boersarie Patosi Relief channel
